SEISMIC RETROFIT OF AN INDUSTRIAL STRUCTURE WITH PBO-FRCM

Giovanni Mantegazza

Alessio Rossato

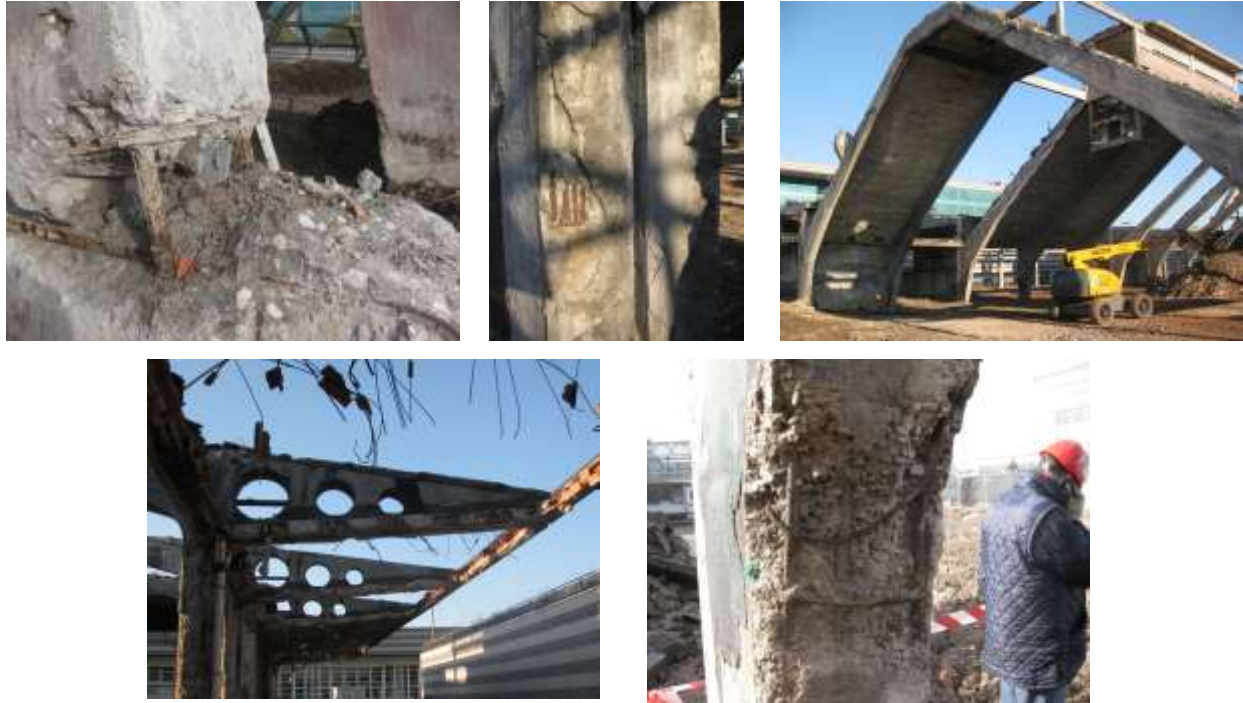
The building, unused for years and exposed to the brackish air of the Venice Lagoon was in a bad state . Expulsion of the covering, rusty reinforcements, widespread disruptions of the concrete are the vastly present all around the building.

Figure 6 - Building before retrofitting

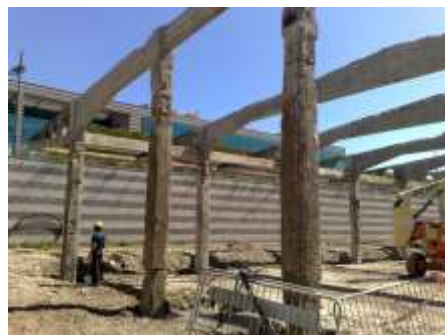
Figure 7 - Corpo C - Original reinforcements

For the actual standards and codes there was also poor reinforcements i.e. stirrups in the node between columns and beams.

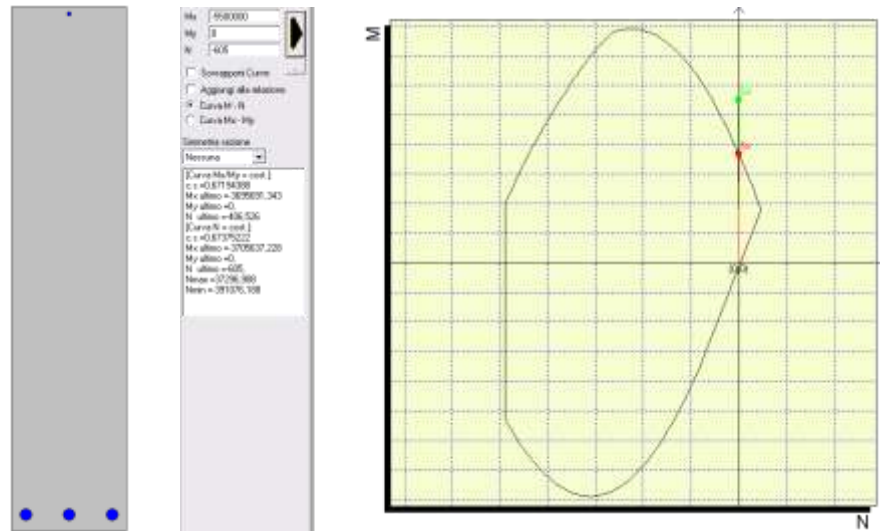
For instance in this section of Corpo A there is a safety coefficient of 0.62 for bending meaning that the bending moment is 1.4 times bigger than the resistant one.

Figure 14 - Bending check of existing arch

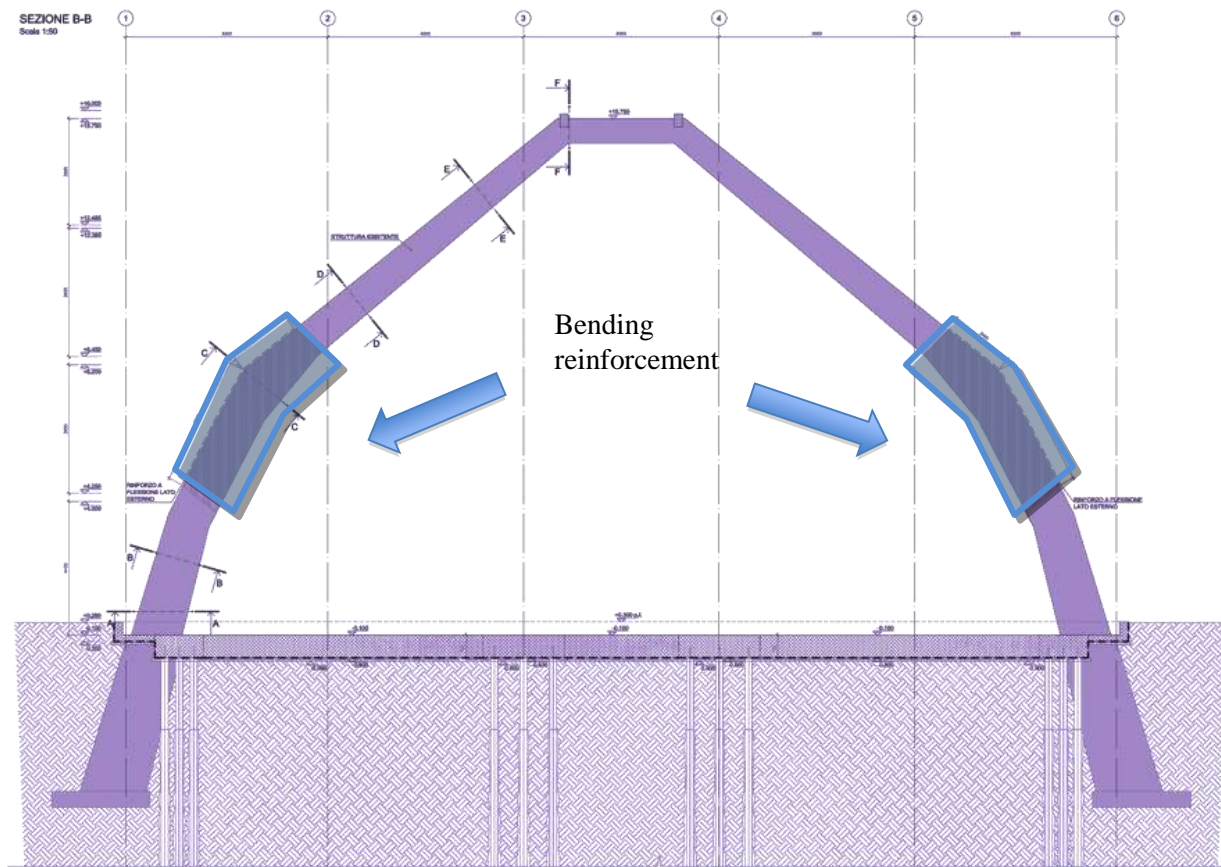
So it was needed a structural reinforcement of concrete arches; we report a map of the typical elements showing where there is the failure:

Figure 15 - Corpo A - Section in need of reinforcement

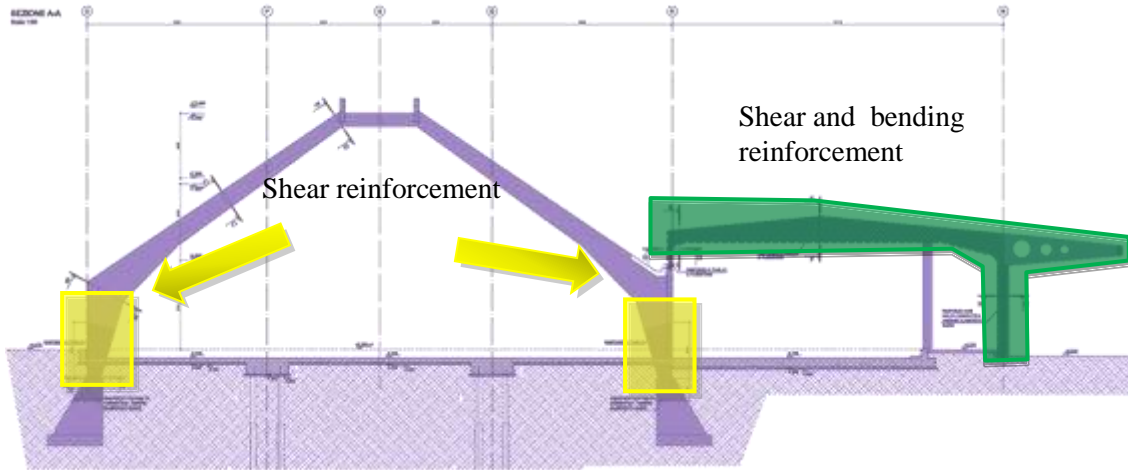
Figure 16 - Corpo B and C - Section in need of reinforcement

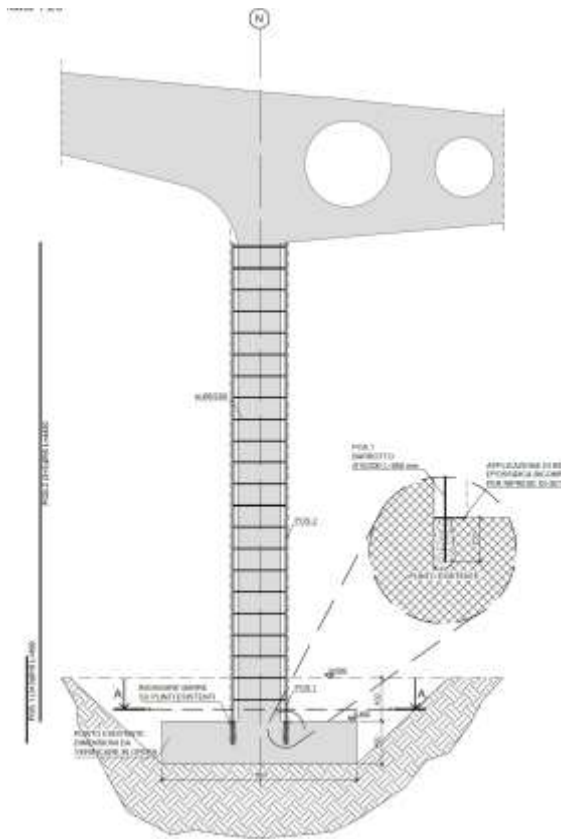
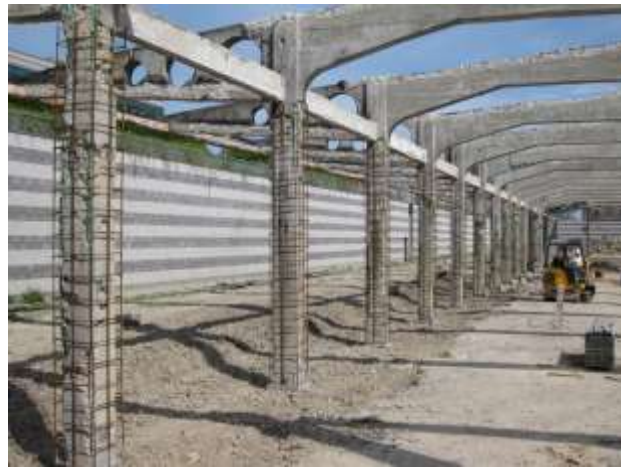
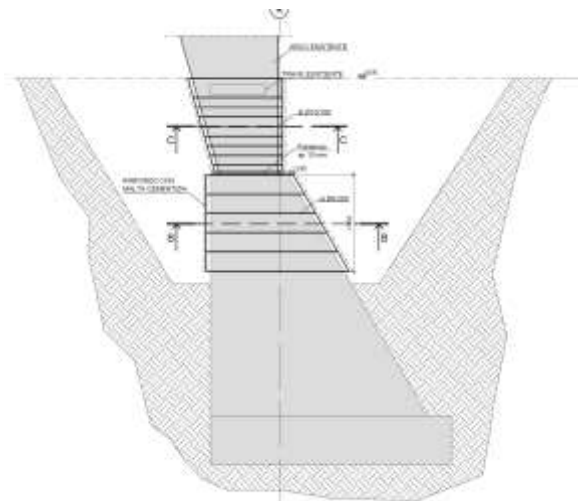
Figure 17 - Reinforcement of Corpo C columns

Reinforcement of foundation of corpo B and columns of corpo C are made with new bars incorporated in a new concrete section. This new covering is made by special grout for structural repairs.

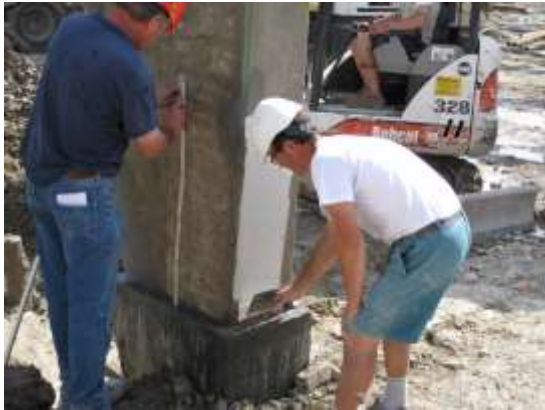
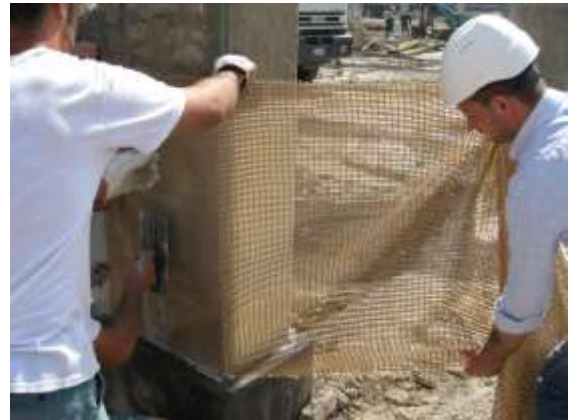
Figure 18 – Shear reinforcement of Corpo B base

The other reinforcements was made with FRCM, Fiber reinforcement cementitious matrix, better described in the next chapter.

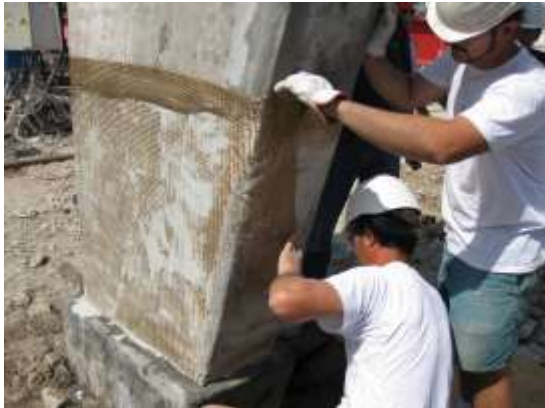
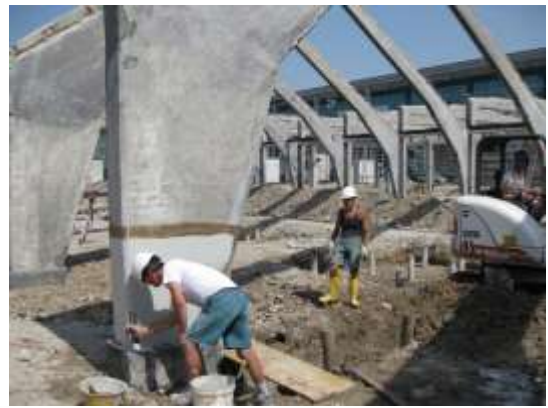
Figure 19 – Shear reinforcement of Corpo B base

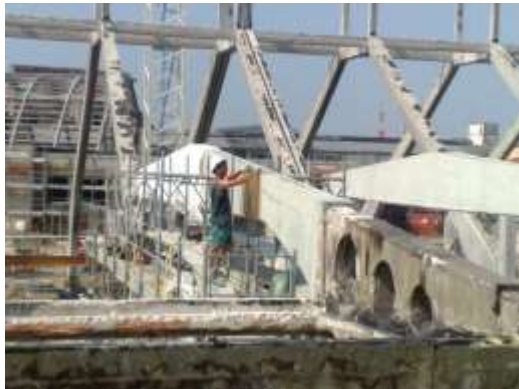
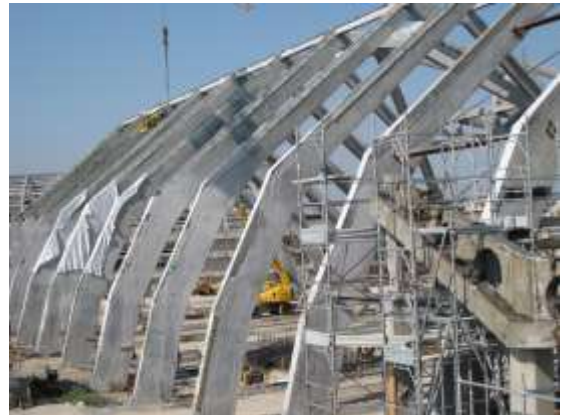
Figure 20 - Reinforcement of Corpo C columns
